REHABILITATION AND IMPROVEMENT OF FATIGUE LIFE OF WELDED JOINTS BY ICR TREATMENT

ABSTRACT: Over 150,000 highway bridges exist in Japan and about 47 percent of the bridges will be over 50 years old in 2026. The Ministry of Land, Infrastructure, Transport and Tourism (MLIT) launched nation-wide projects to inspect and to establish maintenance plans. About one half of the highway bridges were steel bridges with concrete slabs. Due to heavy truck traffics being operated in or between industrial cities, some of which were illegally overloaded, severe deteriorations to concrete slabs and fatigue cracks in steel girders have been observed. Fatigue cracks in orthotropic steel decks were also found. It is urgent to tackle such fatigue cracks observed in welded joints of steel bridges. Various attempts have been made in Japan to repair and rehabilitate such fatigue cracked members. One is to improve fatigue strength of welded joints in existing bridges, and the other is to repair and rehabilitate cracked members. The latter were, for example, re-welding cracked joints, strengthening by using high strength bolted splices, adding glue to cracks, rehabilitating by gluing CFRP. The authors deve

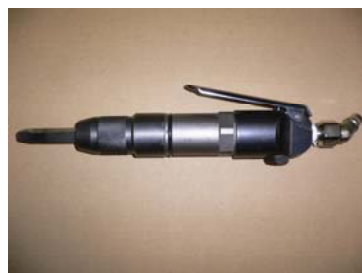
Figure 1. Tools Used for ICR Treatment

The ICR treatment, or Impact Crack Closure technique, is a technique to introduce plastic yielding of steel plate near fillet weld toe or near fatigue cracks. It uses a pneumatic tool to hit steel surface and an air compressor, as shown in Figure 1.

(a) Pneumatic Tool and Tip

(b) Air Compressor

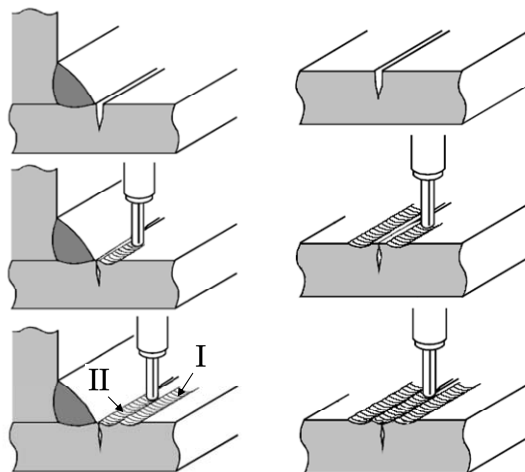
(a) Small Crack at Weld Toe (b) Crack Propagating in Plate
Figure 2. Schematic View of ICR Treatment for Fatigue Crack

The basic concept of the ICR treatment is based on fracture mechanics consideration, as described in Figures 2 and 3. If a crack is found at weld toe, the ICR treatment is carried out at plate near the crack to cause plastic yielding. The surface of the crack is then closed at the surface. If one can create enough plastic yielding, then the crack do not open due to applied stresses. Two steps can be carried out, I and II as shown in Figure 2, to create even larger compressive plastic yielding at the weld toe, if one needs. When the crack propagates to plate, then the ICR treatments are carried out from both sides and on the top of the crack.

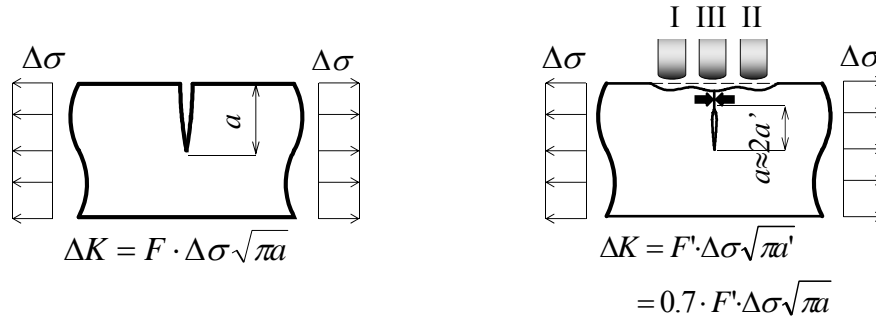
(a) Edge Crack (b) Crack When Crack Remain Closed Due to Applied Load
Figure 3. Schematic View of Repair of Fatigue Crack Using ICR Treatment

The mechanism of the repair of fatigue crack by ICR treatment is briefly described in Figure 3, where a plate with an edge crack is subjected to tension stresses. When the crack is closed and do not open due to the applied stress, the crack can be considered as an internal crack. Then the crack size can be considered as a half of that of the edge crack. Stress intensity factor range, ΔK , which expresses severity of crack tip according to fracture mechanics, becomes about 70 percent of the edge crack. Fatigue crack growth rate, da/dN , of steel is a function of ΔK and is proportional to the power of three of ΔK . Therefore, da/dN slows down to 0.34 times of the one for the edge crack. It implies that the fatigue crack propagation life becomes about three times longer. If the ΔK becomes less than threshold value of stress intensity factor range, ΔK_{th} , below which crack do not propagate, the fatigue life after the ICR treatment becomes infinite.

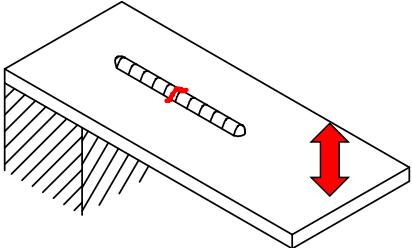
a) Bead on Plate	b) Out-of-plane Gusset Welded Joints

<p>Width and thickness of base plate: 300x12mm ICR treated crack length: 12mm</p>

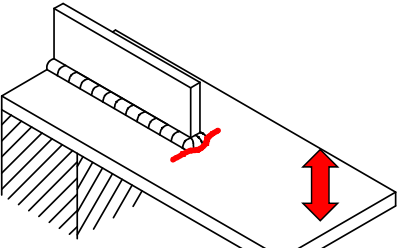
<p>Width and thickness of base plate: 300x12mm Thickness and height of gusset plate : 12x100mm ICR treated crack lengths: N_{10}, N_{20}</p>
c) Plate Edge Gusset Welded Joints (T Joint)	d) Fillet Welded Joints

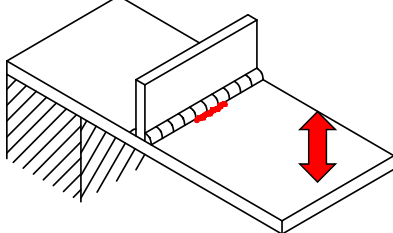
<p>Width and thickness of base plate: 300x12mm Thickness and height of rib plate: 12x100mm ICR treated crack lengths: 12, 24mm</p>
<div style="display: flex; align-items: center;">

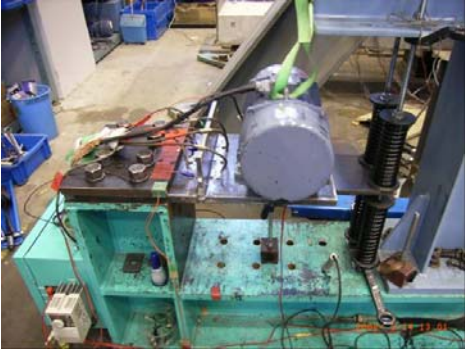
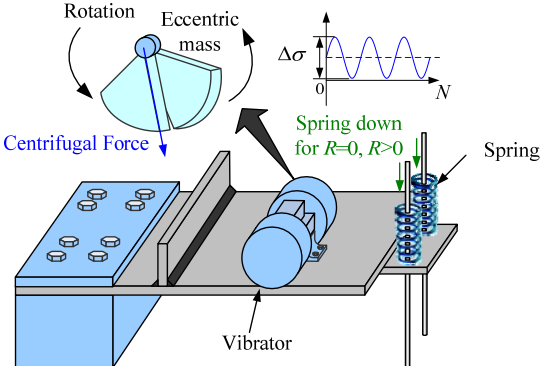
eccentric mass on both side gives repeated loading to specimens. Springs are to give initial static loading in order to obtain desired stress ratio. Strain gages were monitored during fatigue tests to obtain stress ranges to be used for S-N curves. Also attached to the specimens were thin copper wires of 0.04 mm diameter at designated points. The copper wires were connected to the fatigue testing machine. When fatigue crack cut the copper wires, the fatigue testing machine stopped. For example, the copper wires were glued to weld toe, 10 mm from weld toe, and 30 mm of the specimens with out-of-plane gusset. These copper wires helped us to stop the fatigue testing machine automatically at designated crack sizes.

</div> </div> <p style="text-align: center;">Plate-bending Fatigue Testing Machine Used</p>

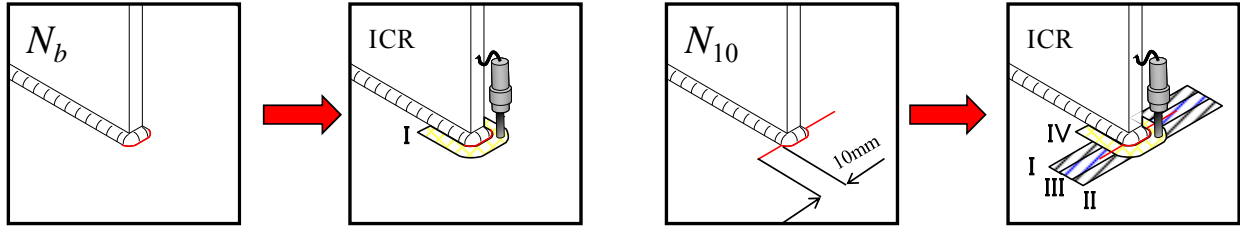
Figure 5. Definition of Crack Sizes and ICR Treatments at N_b and N_{10}

Fatigue tests were carried out for out-of-plane gusset welded joints in bending. First, fatigue cracks were developed at weld toe, and propagated around the turn-around weld of the gusset end, as shown in Figure 5. The crack at this stage was defined as N_b . Then, fatigue crack separated from the weld toe, and propagated to main plate. When the crack became about 10 mm long from weld toe, the crack was defined as N_{10} . The crack was detected by copper wire of 0.04 mm diameter glued at designated location. When the fatigue crack reached and cut the copper wire, it stopped the fatigue testing machine.

The ICR treatment was carried out around fillet weld of the turn-around weld of gusset end for N_b crack, as shown in Figure 5. For N_{10} crack, the ICR treatment was first applied to both sides of the crack in base plate, on top of the crack, and then along the turn-around weld, as shown by I, II, III, and IV in Figure 5.

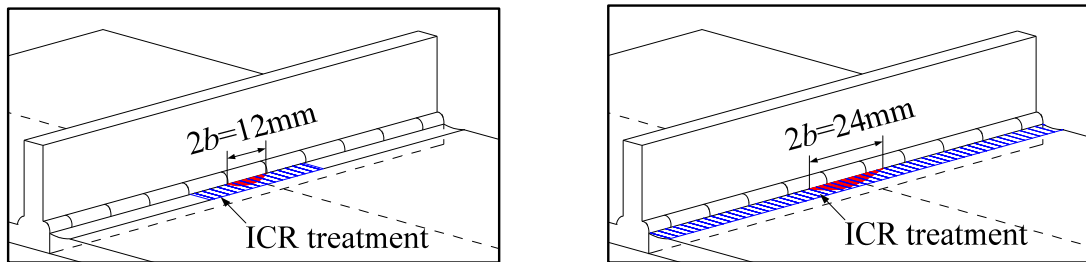
Figure 8. ICR Treatment for Fillet Welded Joints

Fillet welded specimens often showed fatigue cracks along the fillet weld toe. In order to control the size of the semi-elliptical cracks at the fillet weld toe, the ICR treatment was carried out first along the fillet weld toe, but leaving untreated zones at the center of the main plate by 12mm or 24 mm, as shown in Figure 8. After the preliminary fatigue tests, fatigue cracks of $2b=12$ mm or 24 mm were observed along the fillet weld toe.

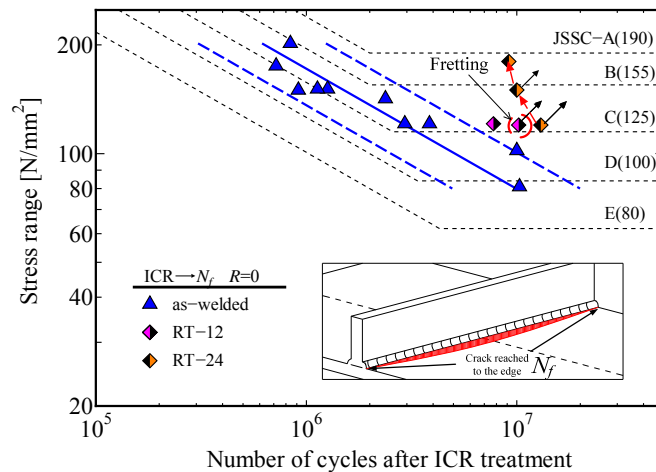
Figure 9. Fatigue Test Results of Fillet Welded Joints with ICR Treatment

Then, the ICR treatments were carried out. For the 12 mm crack, the ICR treatment was carried out along the crack and 20 mm more on both sides. The fatigue life after retrofitting was longer than the upper bound of the as-welded specimens, and retrofitting work was proved to be effective, as shown in Figure 9. By observation of fatigue fracture surface, the 12 mm crack, which initially introduced and ICR-treated, did not propagate. A new fatigue crack initiated and propagated from the weld toe at the point where the ICR treatment was terminated. We found that the beneficial compressive residual stress was diminished by the second application of the ICR treatment.

For the 24 mm crack, we applied the ICR treatment along the whole length of fillet weld toe. Then, no fatigue crack propagation was observed even over 10 million cycles of loading. The applied stress range was increased, but again no fatigue crack propagation was observed over 10 million cycles. Some specimens failed at the support due to fretting fatigue.

The test result shows that ICR treatment is effective to retrofit cracks at fillet weld toe. If the ICR treatment is applied along whole length of the fillet weld, not only at the crack location, the beneficial effect is more significant.

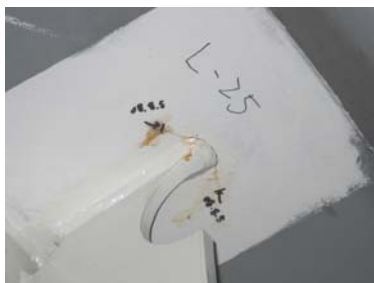
(a) Fatigue Crack at End of Vertical Stiffener

Figure 10. Fatigue Cracks in Orthotropic Steel Decks Retrofitted by ICR Treatment

The ICR treatments were also used to repair and retrofit fatigue cracks observed at upper ends of vertical stiffeners, which were often observed in Japanese orthotropic steel decks (Yamada & Ya [12]), as shown in Figure 10. The details were once retrofitted by drilling circular holes near the cracks. The circular holes were expected to reduce stress concentration at the end of the vertical stiffeners, and hence reduced fatigue crack growth rates. Therefore, the fatigue cracks were left as they were. We applied the ICR treatment to seven locations of these cracks on March 2009.

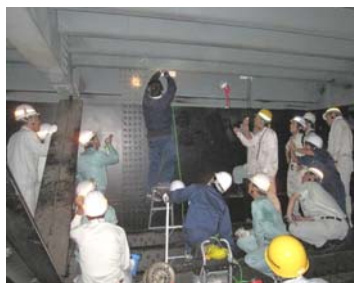
(b) Demonstration of ICR Treatment

The ICR treatments for these cracks took several minutes each, not counting preparation stages. The time needed for ICR treatment was much less than other retrofitting measures. Other retrofitting measure, for example adding high strength bolted splice plates, needed normally several hours with closure of traffic lane.

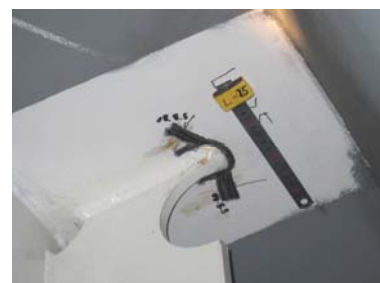
(c) ICR Treated Crack
