# STATIC AND FATIGUE BEHAVIOR OF CFRP-STRENGTHENED RC BRIDGE GIRDERS SUBJECTED TO VEHICLE OVERLOADING

**ABSTRACT:** This paper presents an experimental study into the static and fatigue behavior of three pairs of small-scaled reinforced concrete (RC) bridge girders, in order to investigate the influences of overloading on the fatigue strengthening effects of externally bonded carbon fiber reinforced polymer (CFRP) laminates and understand the mechanisms of fatigue damage accumulation in CFRP-strengthened RC bridge girders under vehicle overloading. Two pairs were strengthened with CFRP laminates and the remained one pair was un-strengthened as references. Two types of overloading were implemented in this test program: one was overloading both prior to and after FRP strengthening and the other was cyclic overloading only after FRP strengthening. At the end of the cyclic overloading all the girders were tested under monotonic loading until failure. Through the evaluation of the pre-fatigue static strength, the development of deflection and cracks during the fatigue loading and the post-fatigue strength of both un-strengthened and CFRP-strengthened RC girders, the effects of the abov

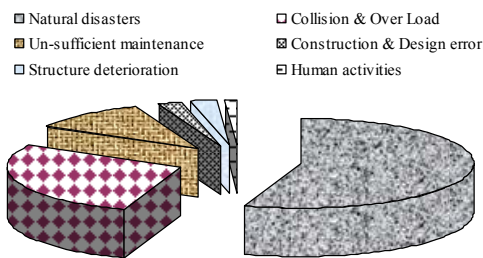
Figure 1. Statistics of Bridge Failures in USA (2000-2008) (Hersi [5])

Reinforced concrete (RC) bridge structures designed for public traffic service usually need to experience millions of loading cycles over their service life. To guarantee the fatigue safety of an RC bridge structure, the load level under a service condition needs to be well controlled so that the working stress in steel reinforcement is lower than a threshold value (e.g., 60% of the yield strength of steel reinforcement) according to AASHTO [1]. However, Karabinis and Kioussis [2] found that the high stress amplitude in steel reinforcement may often exceed the recommended service load level because of the ever-increasing vehicle transportation demand. Sun et al. [3] monitored the structural behavior of a 25 m span simply-supported RC girder bridge in China on basis of the in-situ traffic survey data and found that the maximum stress in the longitudinal reinforcement may reach up to about 85% of its yield strength. Usually the vehicle overloading does not cause an RC bridge to collapse instantly, but the high stress amplitude caused by overloading will definitely accelerate the damage accumulation and the structural performance degradation in critical details [4]. In both USA and China, Hersi [5], Ji and Fu [6] found that vehicle overloading has become a major factor leading to the failure of bridge structures (Figure1 and Figure 2).

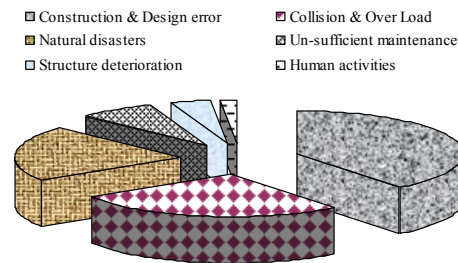
Figure 2. Statistics of Bridge Failures in China (2000-2010) (Ji and Fu [6])

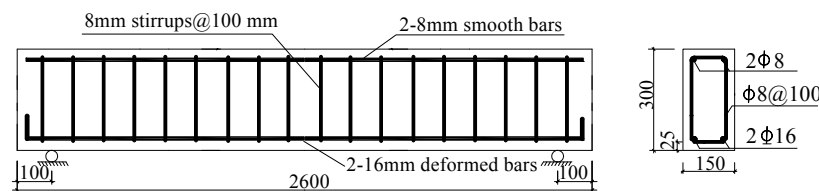
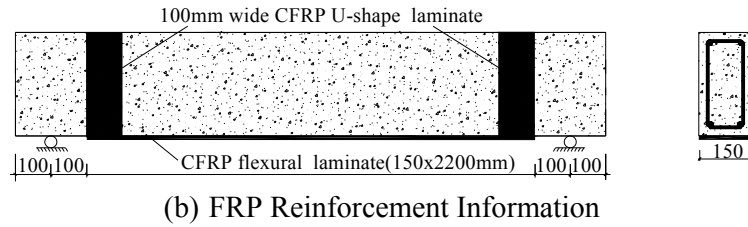
(a) Beam Geometry and Reinforcement Information

Figure 3. Details of Test Beams (unit: mm)

Six RC beams with a rectangular cross section of  $150 \times 300$  mm and a testing span of 2400 mm were prepared in this study (Figure 3a). Each beam was reinforced with two tensile deformed bars of 16 mm in diameter, which had a concrete cover of 25 mm, two round bars 8 mm-diameter in the compressive zone, and steel stirrups of 8 mm in diameter and 100 mm in spacing (Figure 3a).

Among the six RC beams, four beams were externally strengthened in flexure with one layer of unidirectional CFRP sheet and two beams were un-strengthened as control specimens (see Table 1). As shown in Figure 3b, the CFRP sheet was 150 mm wide and 2200 mm long. Two U-shape anchorages were installed at the two ends of the CFRP sheet to prevent plate-end failure. Table 1 presents a summary of all the specimens. Beams BC0 and BC1 were un-strengthened. BC0 was loaded under monotonic static loading until failure while BC1 was cyclically overloaded before the monotonic static loading test. Beams BR0 and BR1 were all strengthened with 1 layer of CFRP sheet, and their loading schemes were the same as those of BC0 and BC1, respectively. Beams BD0 and BD1 are similar to beams BR0 and BR1 except that they had experienced initial overloading damage prior to CFRP strengthening. This initial damage caused the yielding of tensile steel reinforcement as shown in Figure 4. At the end of overloading, the width of the major crack (i.e. the one that had the maximum crack width) reached 1.0 mm.

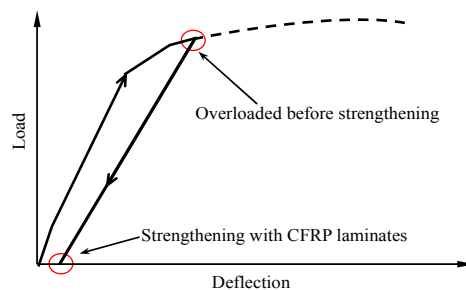
Figure 4. Introduction of Initial Overloading Damage Prior to FRP Strengthening

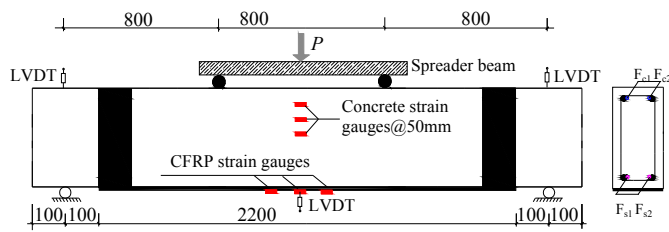
(a) Four-point Loading Diagram

Figure 5. Test Set-up (unit: mm)

All the beams were subjected to four-point bending over a simply supported span of 2400 mm as shown in Figure 5a. An 800 mm long constant moment zone existed in the middle part of the beams. The monotonic and fatigue loads were applied onto the beams using an MTS machine, as illuminated in Figure 5b. During the production of the beams, optic fiber sensors were embedded in the beams to monitor the strains of concrete (see locations  $F_{c1}$  and  $F_{c2}$  in Figure 5a) and steel reinforcement (see locations  $F_{s1}$  and  $F_{s2}$  in Figure 5a). Prior to the tests, three gauges were also placed on the concrete surface at the heights of 250mm, 200mm and 150mm, respectively, from the top of the beam (Figure 5a). In addition, three gauges were attached on the surface of CFRP sheet within the constant moment zone (Figure 5a). Three linear voltage displacement transducers (LVDTs) were installed at the mid-span and support locations to obtain the mid-span deflection. During the tests, all the loads, displacement and strains were recorded using a data acquisition system.

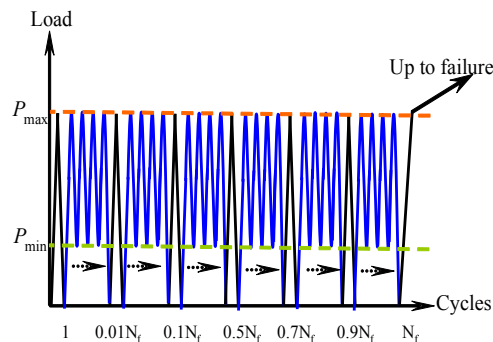
Figure 6. Loading Sequence of Fatigue Tests

As mentioned previously, there were two loading schemes: monotonic static loading and cyclic overloading. The un-strengthened control beam was loaded monotonically to failure to identify its ultimate load ( $P_u$ ) firstly. Then the load sequence for fatigue tests was implemented as shown in

Figure 6. During the fatigue tests, the upper bound load (i.e.,  $P_{max}$ ) was set as  $0.8P_u$  and the low bound load (i.e.,  $P_{min}$ ) was set as  $0.35 P_u$  for both un-strengthened and CFRP-strengthened RC beams according to the in-situ survey carried out by Sun [3]. The fatigue loading was applied using a form of sinusoidal wave with a frequency of 2 Hz and the total number of fatigue cycles  $N_f$  was set as 10000 in the tests. Since it was difficult to record all the strain and deflection information during the whole fatigue loading period, the fatigue tests were stopped at certain numbers of fatigue cycles (i.e. 1<sup>st</sup>,  $0.01 N_f$ ,  $0.1 N_f$ ,  $0.5 N_f$ ,  $0.7 N_f$ ,  $0.9 N_f$ , and  $N_f$ ). At these cycles, all the beams were unloaded and then reloaded to  $0.8P_u$  and the structural responses including the sectional strains, deflections, crack patterns and the maximum crack widths were measured. At the end of the fatigue cycles, all the beams were loaded monotonically to failure.

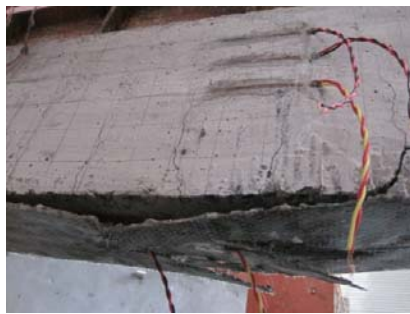
(a) Beam BR0

Figure 7. Failure Modes of CFRP-strengthened RC Beams under Monotonic Static Loading and Fatigue Loading

The control beam BC0 failed in a typical flexural mode by concrete crushing long after the yielding of steel reinforcement. The CFRP-strengthened RC beam BR0 failed due to the mid-span debonding of CFRP sheet (Figure 7a). However, the other CFRP-strengthened RC beam BD0, which experienced initial overloading damage, failed due to the fracture of CFRP sheets at the location of the maximum crack before the interfacial debonding (Figure 7b). It should be mentioned that the cracks in concrete due to overloading were sealed with epoxy resins prior to the strengthening of the beam BD0 and BD1. The CFRP-strengthened RC beam BR1, which experienced cyclic overloading, failed due to the mid-span debonding of CFRP sheet followed by its brittle rupture (Figure 7c). The CFRP-strengthened RC beam BD1, which experienced initial overloading damage and then cyclic overloading, exhibited the similar failure mode (Figure 7d) as beam BR1.

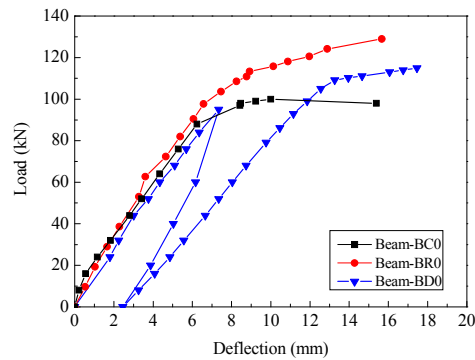
Figure 8. Load-deflection Responses of Beams Tested under Monotonic Loading

Figure 8 shows the load-deflection responses of beams BC0, BR0 and BD0 tested under monotonic static loading. It is shown that the beams BC0 and BR0 exhibited the similar load-deflection responses till the yielding of steel reinforcement while the latter had a slightly larger bending stiffness. Compared to BC0, BR0 achieved an increased ultimate strength by 29% due to the FRP strengthening effect. At all the loading stages, beam BD0 experienced larger mid-span deflections than BR0 due to the initial damage induced by the overloading prior to the FRP strengthening (Figure 8). Due to the presence of significant plastic deformation before the FRP strengthening, the ultimate load achieved by the beam BD0 was obviously less than that achieved by the beam BR0. Compared to the un-strengthened beam BC0, beam BD0 only achieved an increase in the ultimate strength by 15%.

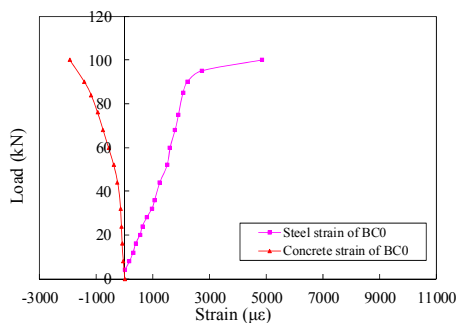
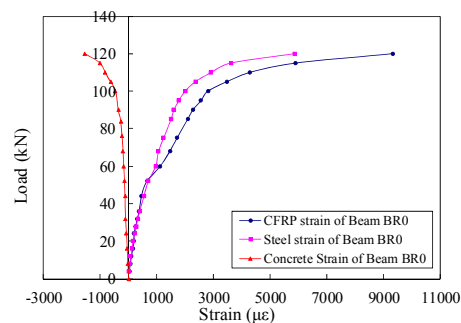
Figure 9. Strain Development in FRP, Concrete and Reinforcement under Monotonic Loading

Figures 9a-9c shows the development of strains in CFRP, steel reinforcement and concrete with the load. It is shown that at the same load level, the strain in steel reinforcement was decreased in case of FRP-strengthened RC beams as expected. In beam BD0, there was a strain delay in FRP at the early loading stage due to the initial overloading damage. While later on, the strain development in FRP was more rapid than that in steel reinforcement in both BR0 and BD0 beams, which followed the plane sectional assumption. It is interesting to find that the strain development of FRP in beam BD0 was more rapid than that in beam BR0 at the latter loading stage (Figure 9d). This is probably because of the strain localization of FRP at the location of the major crack caused by the initial overloading damage. This also explains why the rupture of FRP occurred in beam BD0 rather than the debonding of FRP as observed in beam BR0 at the ultimate state.
