MECHANICAL PROPERTIES OF CORRODED HIGH PERFORMANCE STEEL SPECIMENS BASED ON 3D SCANNING

High performance steel;
Mechanical property;
3D scanning technology;
Corrosion;
FEM

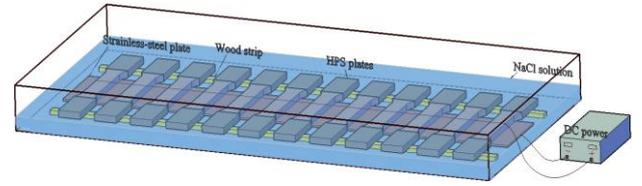
Fig. 2 Schematic diagram of accelerated corrosion test

In this research, the mass loss rate was used to control the corrosion time. To accelerate the corrosion process, an electrochemical accelerated corrosion method was employed. As illustrated in Fig. 2, twelve steel specimens, connected in series with copper wires at the central position, were placed in the plastic groove with a 5% NaCl solution. To prevent corrosion of the gripped end, epoxy resin and waterproof tape were used to wrap it tightly. The specimens were linked to the positive end as the anode. One stainless steel plate, as the cathode, was connected to the negative end of the DC power supply providing a stable electric current of 1000mA. Under the action of current, the anode undergoes an oxidation reaction, and the Fe²⁺ produced on the surface of the steel plate is continuously lost. Meanwhile, the cathode undergoes a reduction reaction. As a result, electrochemical corrosion occurs, and the corrosion rate can be controlled by adjusting the applied electric current. In order to achieve the designed degree of corrosion, Faraday's law was employed to estimate the duration of the applied corrosion current [29]. After reaching a specified corrosion level, the corroded steel specimens were taken out from the plastic tank and cleaned according to the procedure described in ASTM G1-03 [30], and then the mass loss rate was calculated and listed in Table 3.

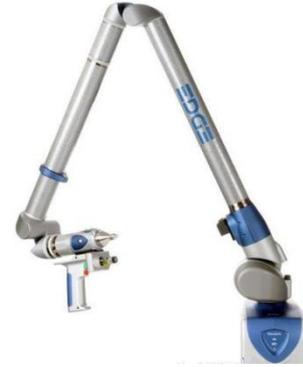
Fig. 3 A 3D scanning device

After cleaning, a 3D scanning device (see Fig. 3) with accuracy of $29\ \mu\text{m}$ was employed to reconstruct the geometric model of the corroded specimens. Optimized operations, such as filtering and noise processing, were performed to obtain more realistic point cloud data by using Geomagic Control software. A curved surfaces model was generated based on the point cloud data. Finally, the geometrical dimensions of corroded specimens can be determined. All the corroded steel specimens were treated with 3D scanning, and some specimens were extracted to compare the difference between the real shape and the 3D geometry model. As shown in Fig. 4, 3D laser scanning can well reflect the surface morphology of corroded steel specimens.

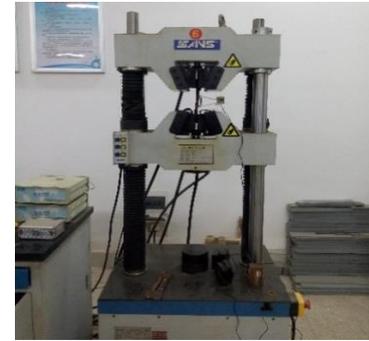
Fig. 5 Universal testing machine

All the specimens were tested on the microcomputer controlled electro-hydraulic servo universal testing machine, as shown in Fig. 5. The extensometer was placed within the gauge range to measure the elongation of the specimen [31]. The tensile test was controlled by displacement until the specimens failed. The load displacement curve can be automatically recorded by the computer, and the characteristic mechanical parameters, such as yield load, ultimate load, and elongation can be conveniently determined. The tensile test results were shown in Table 3.

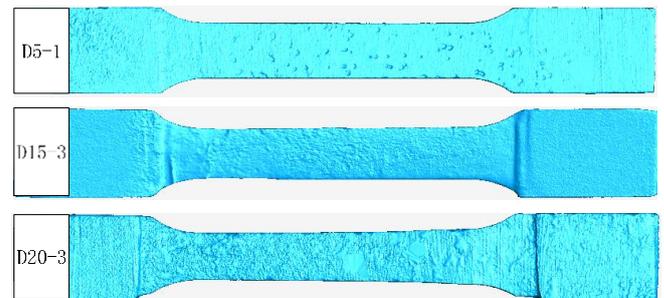
Fig. 6 3D scanning morphologies of steel specimens

To visually appreciate the geometrical characteristics of the corroded HPS specimens, the scanned images of steel specimens with different corrosion levels are showed in Fig. 6. As Fig. 6 shows, the cross-sectional losses of the steel specimens are not evenly distributed both around the width and the length of the specimen. The surface of specimen D5-1 with low corrosion damage is relatively flat and has small pits. The cross-section sizes of specimens reduce gradually as corrosion degree increases, and the large corrosion pits even disappeared for seriously corroded specimen D20-3. This phenomenon is inconsistent with corrosion behavior of steel bars. This is because the diffusion process of chloride ions in each direction for steel bars in concrete is variable [32-33]. Fig. 7 presents the cross-sectional area of the corresponding specimens. The cross-section profile of specimens varies from flat to irregular shape with the increasing corrosion loss. Therefore, the weakest cross section position is unknown and is difficult to determine through ordinary methods.

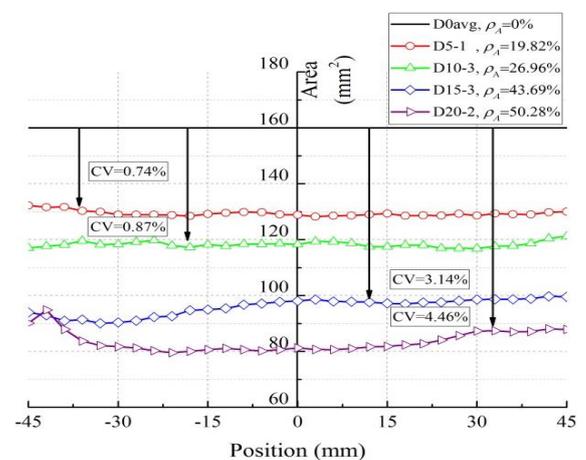
Fig. 8 Longitudinal distribution of cross section area

In addition, the residual sectional area with a spacing 3mm along the length of specimens was obtained with Geomagic Control software. The discreteness of the cross-sectional area is characterized by Discrete Coefficient (CV). Fig. 8 plots the variation of cross-sectional areas of specimens. As Fig. 8 shows, the cross-sectional area of steel specimens decreases gradually from $130\ \text{mm}^2$ to $80\ \text{mm}^2$ as the corrosion rate increases from 19.82% to 50.28%. The CV increases as corrosion gradually becomes serious. For example, the increase of CV in specimen D20-2 is 6.03 times that of specimen D5-1. This shows that the cross-sectional distribution is very uneven when a structure is corroded seriously.

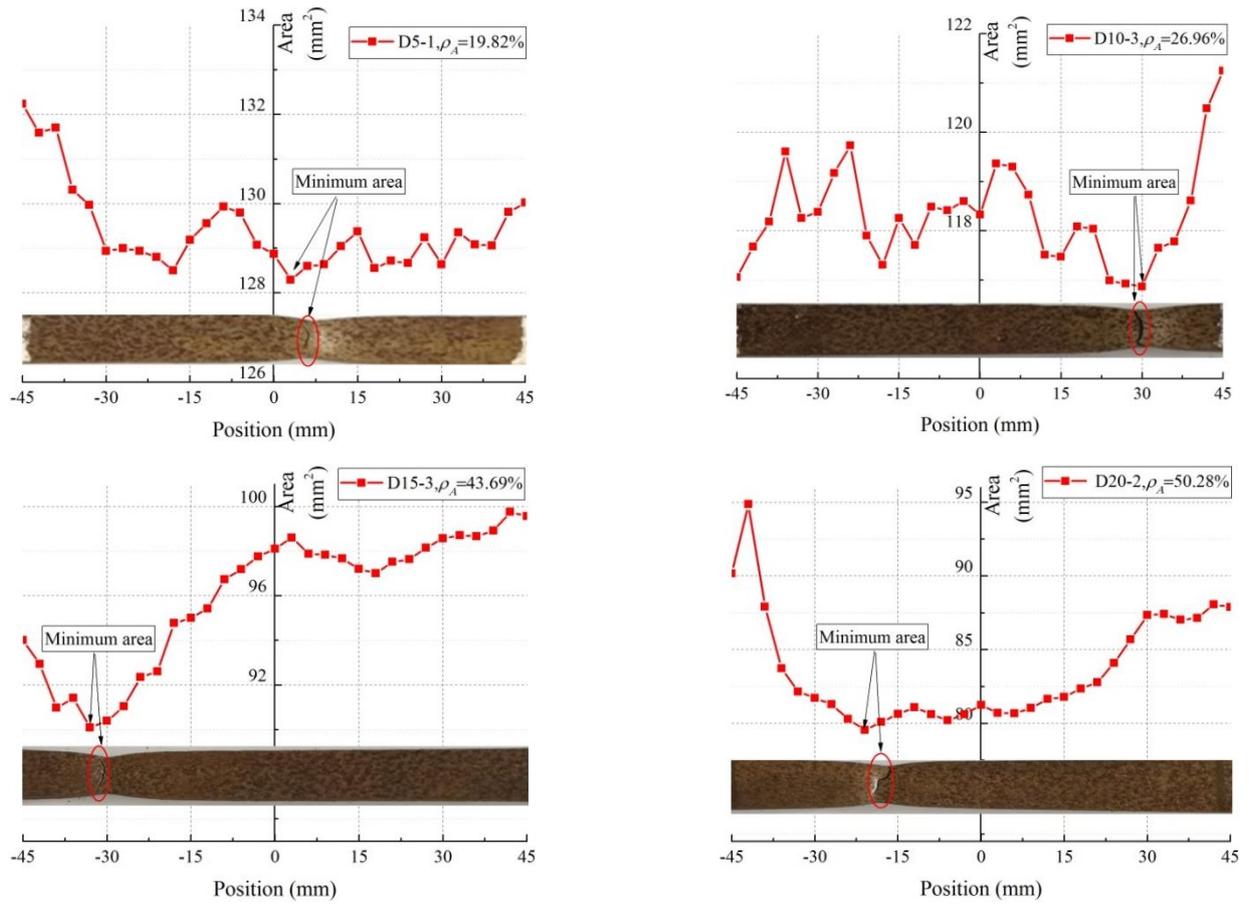
Fig. 9 Representative area-position diagram

Fig. 9 shows the cross-sectional area distribution and fracture position of the corroded HPS specimens. As Fig. 9 shows, the areas of steel specimens randomly change along the longitudinal direction, which indicates the randomness of the corrosion damage. The minimum cross-sectional area of the corroded specimen is very close to the fracture position, which suggests that it is reasonable to characterize mechanical properties of the corroded steel specimens with the maximum cross-sectional loss ratio [34]. This is different from some researches [35] taking the minimum thickness or maximum corrosion depth as the corrosion parameters, because the section loss of steel specimens includes the loss rates in both the width direction and the depth direction in this test. In addition, the assumption that the mass loss rate is used to characterize the corrosion degree can be ruled out by considering that slight corrosion occurs at the clamping ends of specimens. Therefore, the maximum cross-sectional loss ratio ρ_A , as listed in Table 3, is used to analyze the mechanical properties of the corroded HPS specimens in this study.

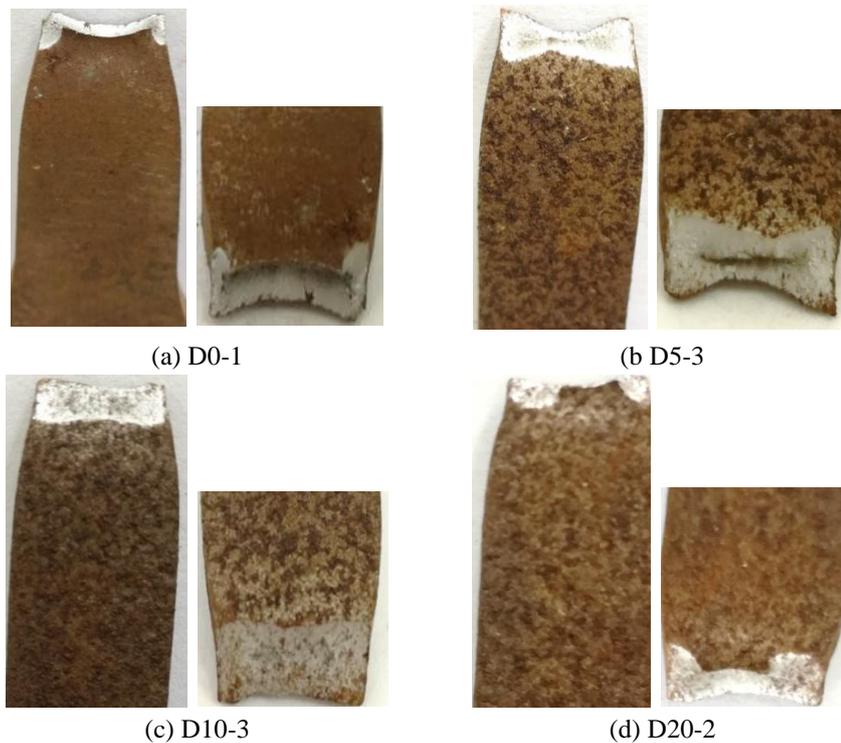
Fig. 10 Fracture morphologies

The fracture characteristics of specimens D0-1, D5-3, D10-3, and D20-2 are shown in Fig. 10. The fracture shape of the non-corroded specimen D0-1 is crescent. Obvious dimples and necking are observed on the fracture section, which can be considered as a ductile failure. As the corrosion degree

increases, the fracture features of the corroded specimens D5-3 and D10-3 change from the crescent to regular shape, while the fracture condition of specimens D20-2 subjected to severe corrosion is irregular. The dimples

gradually disappear, and then the failure behavior varies from ductile to brittle. This implies that corrosion gradually transforms the failure mode from the ductile failure to brittle failure. This is probably due to the impact of both corrosion pits and the irregular shape of cross-section, which makes the

(2) Corrosion affects significantly the tensile failure of the HPS specimens, which changes the fracture morphology of specimens from crescent to irregular shape. The failure of the seriously corroded specimens is very brittle without obvious dimples and necking at the fracture surface.

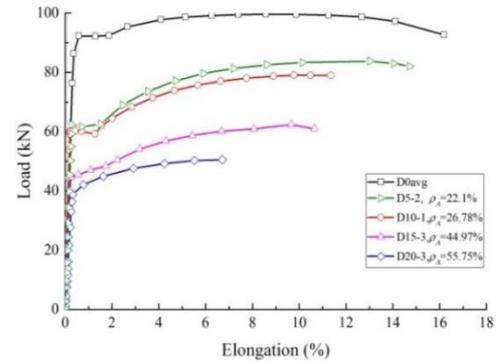
Fig. 11 Load-elongation curves

Fig. 11 presents the load-elongation curves of some representative specimens after static tensile tests. As Fig. 11 shows, the load-elongation results are quite different as a result of the different degrees of corrosion damage. The yield load of specimen D20-3 with a 55.75% corrosion rate is 60.5% lower than that of the control specimen D0avg, and the ultimate load is decreased by 49.3%. There are obvious yield plateau and necking stage before the fracture failure for specimens D0avg and D5-2. When the ρ_A reaches 26.78%, the necking phenomenon of specimen D10-1 disappears and the yield plateau shortens obviously. For severe corrosion specimens D15-3 and D20-3, an obvious yield plateau cannot be observed. Therefore, corrosion has an adverse impact on the strength and deformation of corroded HPS specimens.

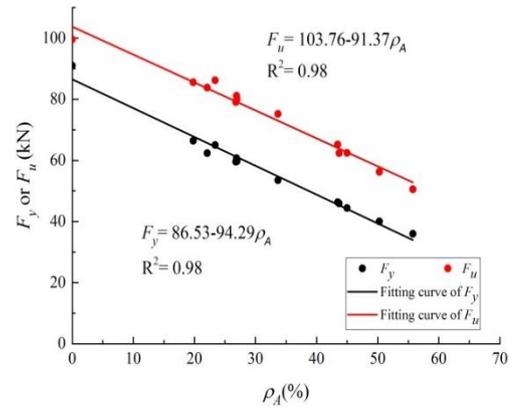
Fig. 12 Effect of corrosion on yield and ultimate load

Results are presented in Fig. 12 and Fig. 13 in terms of ρ_A versus yield load F_y and the ultimate load F_u and ρ_A versus the relative elongation, respectively. The relative elongation δ_r is defined as the ratio of elongation of corroded specimens and that of the control specimens. As Fig. 12 shows, both F_y and F_u decrease linearly with the increase of the maximum cross-sectional loss ratio ρ_A . The load degradation of F_y is faster than that of F_u , which indicates that corrosion has a more adverse impacts on the yield load degradation. The high R-squared values further confirm the rationality of applying the maximum cross-sectional loss ratio to predict the degradation of mechanical properties. As showed in Fig. 13, the relative elongation δ_r decreases gradually as the maximum cross-sectional loss ratio ρ_A increases. Through regression analysis with Origin software, a parabolic attenuation model is considered to be a good agreement with the tested data. The degradation of δ_r caused by corrosion (lower than 25%) is relatively small. With further corrosion, it drops sharply. This can be explained that the cross section of the corroded steel specimens is very unevenly distributed along the axial direction, and the phenomenon of sectional eccentricity and stress concentration are ubiquitous, resulting in complex multi-axial stress under axial tension. The minimum section would reach the ultimate stress in advance, then the necking behavior occurs prematurely, and finally the elongation at ultimate load decreases. When the degree of corrosion exceeds a critical value, the phenomenon is prominent.

(3) The yield and ultimate load decrease linearly as the maximum cross-sectional loss ratio increases. The relative nominal or real yield strength decreases exponentially, while the relative nominal or real ultimate strength increase in a similar parabolic way.

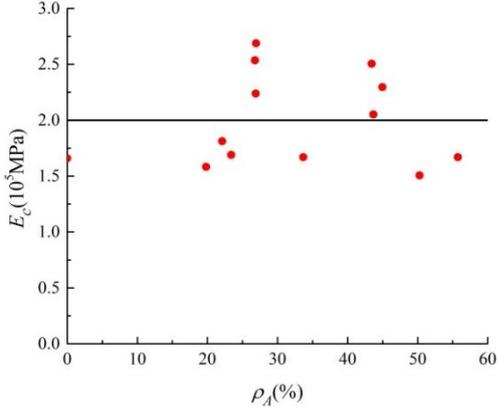
Fig. 14 Effect of corrosion on elastic modulus

Zhang et al. [36] found that the elastic modulus was not affected by corrosion for ordinary corroded steel specimens. In order to understand how the corrosion influences the elastic modulus of the HPS specimens, the relation between the elastic modulus and the maximum cross-sectional loss ratio is analyzed as shown in Fig. 14. With the increase of ρ_A , the variation pattern of the elastic modulus changes insignificantly, and it fluctuates near a certain value. Therefore, we can assume the ρ_A does not affect the elastic modulus. The fluctuation of elastic modulus is mainly due to the variation of the different specimens and test error. This phenomenon is similar to that of corroded ordinary steel and corroded steel bars [36]. Therefore, the effect of corrosion on the elastic modulus is ignored.

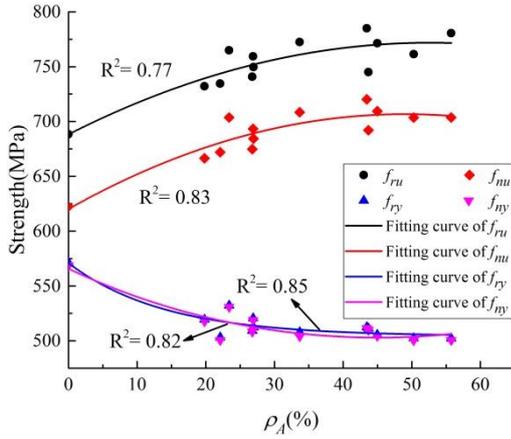
Fig. 15 Effect of corrosion on yield strength and ultimate strength

Fig. 15 shows the variation of the yield strength and ultimate strength with the corrosion rate. As shown in Fig.15, the nominal and real yield strength decrease almost by following the same path, while the nominal and real ultimate strength increase with the maximum cross-sectional loss ratio. This is due to the large stiffness of the HPS specimens and the small reduction of the cross-sectional area under the yield load, which would not cause obvious decline of f_{ry} and f_{ny} . However, f_{ru} and f_{nu} are obviously different as the area has changed obviously during the tensile test. Fig. 16 presents the relative nominal and real yield strength, and the relative nominal and real ultimate strength are plotted in Fig. 17. It could be noticed that the relative nominal or real yield strength decreases exponentially with the increase of the maximum cross-sectional loss ratio, while the increase of the relative nominal or real ultimate strength conforms to a similar parabolic law. This provides a new path to determine the real yield strength and the real ultimate strength of the corroded HPS specimens.

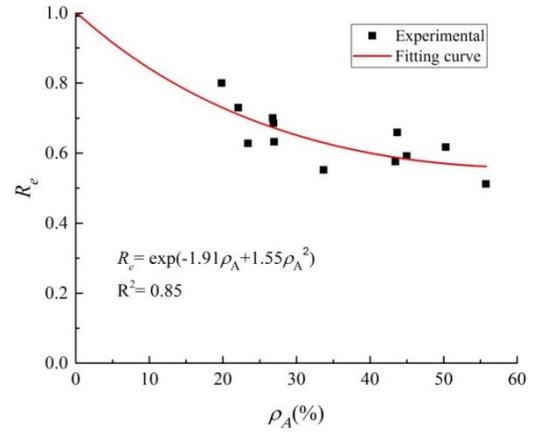
Fig. 18 Effect of corrosion on ductility

Fig. 18 shows the impact of corrosion damage on the ductility of the HPS specimens characterized by R_e . As shown in Fig. 18, R_e decreases rapidly when ρ_A is less than 32%, and then R_e reduces slowly with the increase of ρ_A . The deterioration characteristic of R_e is well fitted by the exponential function. The law of energy attenuation is similar to the results of corroded steel rebar carried out by other researchers [39].

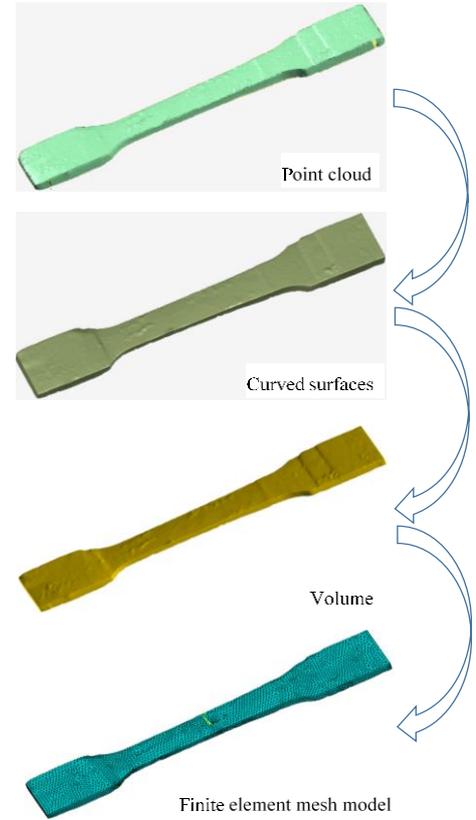
Fig. 19 Establishment process of 3D finite element model

Finite element models are established to further investigate the strength, stress distribution, and fracture behaviors of the corroded HPS specimens. The real geometry model of the corroded specimen is applied to develop the numerical model. The corrosion morphology of the specimen can be truly reflected in the finite element model. Fig. 19 depicts the main process from the point cloud file to the final solid finite element mesh model. The point cloud data of the corroded specimen is fitted to the curved surfaces after wrapping, repairing, and grid division by the Geomagic software. Subsequently, the IGES format file is exported to the ANSYS software for numerical simulation.

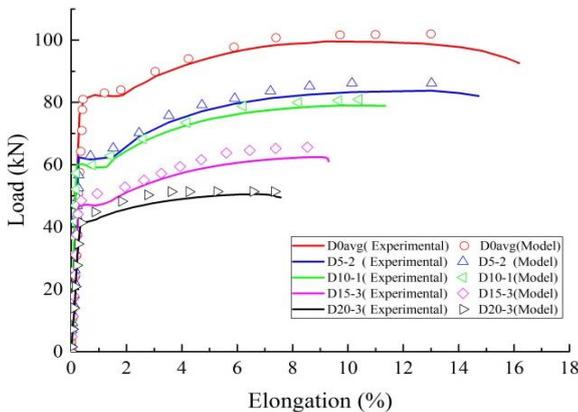
Fig. 20 Comparison of experimental and numerical load-elongation curves

Fig. 20 presents a comparison of numerical and experimental load-elongation behaviors of steel specimens subjected to corrosion. As Fig. 20 shows, the result of numerical simulation is slightly higher than the test one because of the more ideal constraints in the numerical model. In general, the numerical results are in good agreement with the experimental values. This indicates that the finite element model established in this paper based on 3D scanning can well describe the failure behavior of the corroded specimens.

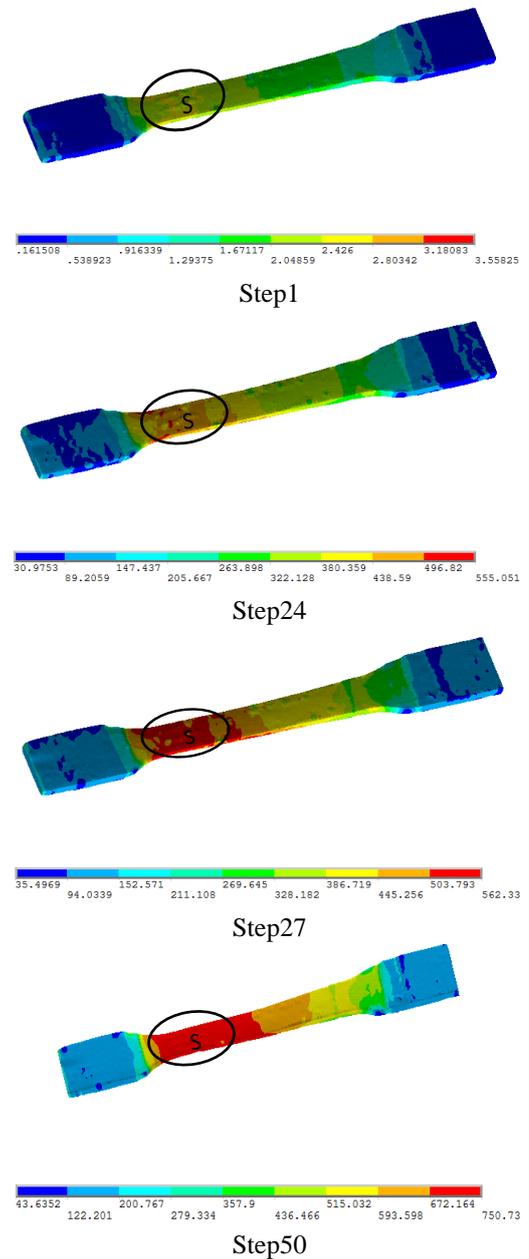
Fig. 21 Stress nephogram of specimen D20-3 at different time steps (unit: MPa)

Fig. 21 presents the stress diagrams of specimen D20-3 at different time steps. As shown in the figure, the stress distribution is uneven. The stress in the S region is maximal, and reaches yielding strength firstly. The associated necking behavior is more obvious in this region. This can be attributed to the thinner cross-section area and the sharper corrosion pits in this section. The comprehensive effect would result in the formation of complex stresses, and lead to non-uniform deformation and premature yielding and failure.

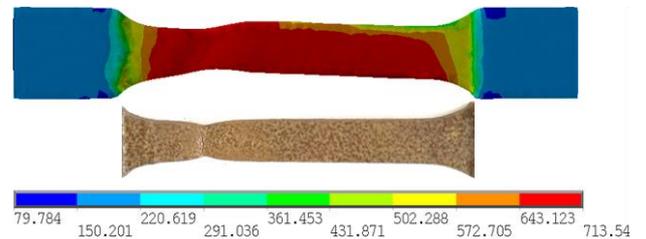
Fig. 22 Stress distribution at ultimate load

Fig. 22 presents the stress distribution at the ultimate load of specimen D15-3. It can be seen that the stress from the numerical simulation is close to the real stress of the test. The maximum necking position of the numerical model is almost the same as the fracture position of the test one, which occurs at the minimum cross-section position. This indicates that the finite element model based on the 3D scanning can truly reflect the failure behavior of the corroded HPS.
