FLEXURAL STRENGTH OF WEATHERED GRANITES UNDER WETTING – DRYING CYCLES: IMPLICATIONS TO STEEL STRUCTURES

Sarkar Noor-E-Khuda ^{1,*} and Faris Albermani ²

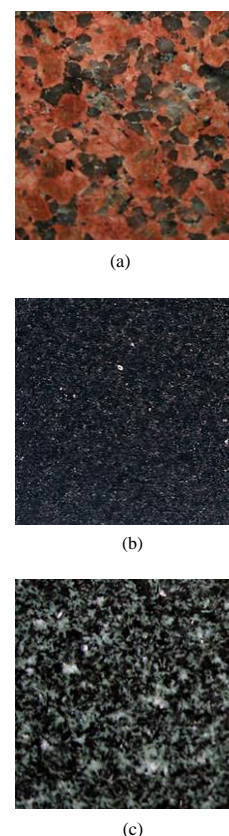
Fig. 1 Granite types (a) Calca; (b) Imperial Black; (c) Grandee [5]

Three common Australian granite types; Calca, Imperial Black (or Adelaide Black) and Grandee were used in this study. Petrographic description of the selected granite types is summarised in Table 1. Key features of these three stones are high compressive strength, hardness, durability, visible crystalline structure with interlocking crystals of medium to coarse grain and highly polished surfaces. The stones can be distinguished by their appearances as shown in Fig. 1.

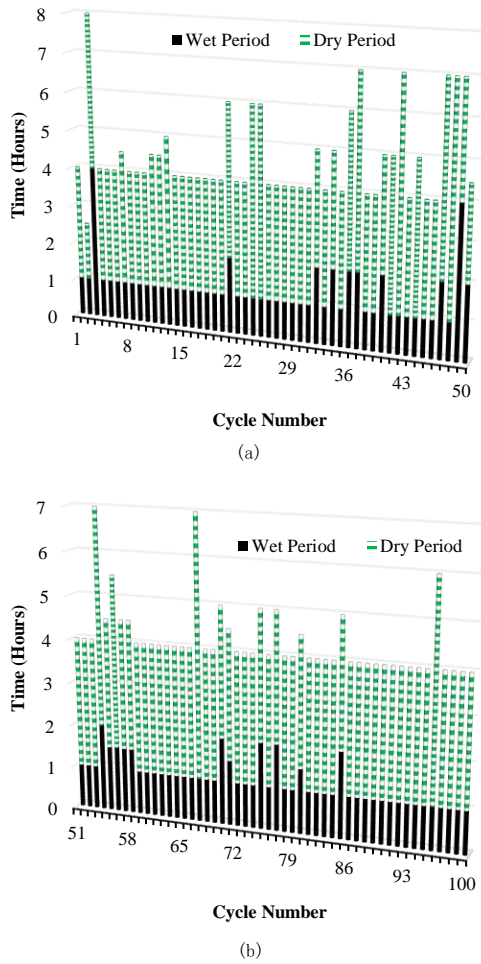
Fig. 2 Wetting – drying cycles (a) Stage – I; (b) Stage – II

Fig. 2 (a) shows Stage I of the weathering process that consisted of fifty WDC. In each wetting cycle as shown in Fig. 3(a), the specimens were grouped according to their granite type and were fully immersed in separate tanks of tap water for one hour in room temperature. This process was done manually with fresh tap water used to fill the tanks and was discarded at the end of each wetting cycle. In each drying cycle, the specimens were placed on shelves in a drying chamber as shown in Fig. 3b. Warm air was blown onto the specimens and the temperature in the chamber was maintained at 40 °C for three to six hours. At the end of the fiftieth cycle, the specimens were left to dry in open air for 48 hours, then weighed. Three specimens from each granite type were randomly selected for an interim UPV test.

Fig. 2 (b) shows Stage II of WDC. In Stage II, tap water was used in wetting cycles for 5 specimens of each granite type while for the remaining 5 specimens acidified water was used in the wetting cycle. Different tanks were used in Stage II for different granite types and groups (i.e., tap water and acidified groups).

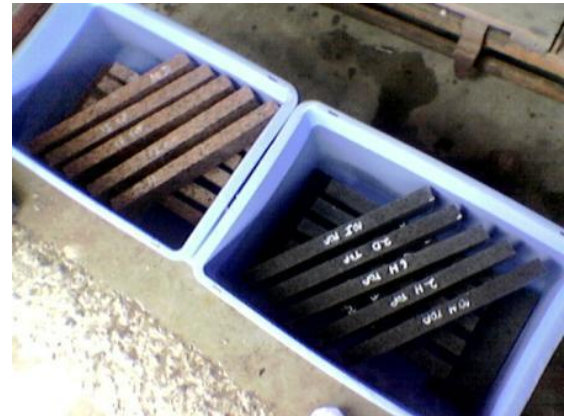
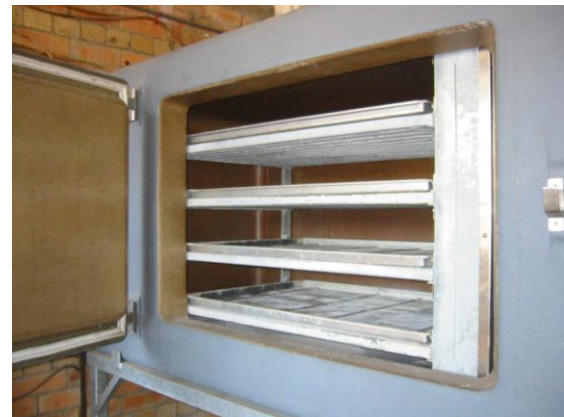
Fig. 3 Experimental setup (a) Wetting; (b) Drying

Total 45 specimens, 15 for each granite type were randomly selected from a pile of granite coupons which were stacked outdoors under exposure to natural weather conditions. The nominal dimensions of a typical coupon is: 400 × 100 × 30 mm (length × width × thickness). Only one face (400 × 100 mm) of each coupon is polished. The specimens were grouped into three batches: tapwater, acidified and control groups. A total of 30 specimens (10 of each stone type, S1–S10) were subjected to the WDC while another 15 control specimens (5 of each stone type, C1–C5) were preserved as the unweathered reference. Each specimen was weighed and, their dimensions were carefully checked and recorded according to the flexural test requirements of ASTM C880/C880M [22]. The tapwater and acidified group specimens were then subjected to the WDC in two separate stages. Fig. 2 and Fig. 3 shows the WDC cycles used in the experimental program and the experimental setup, respectively.

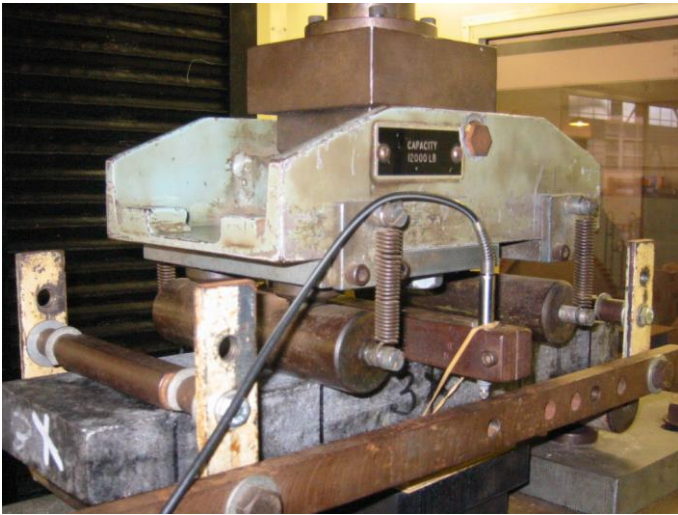
Fig. 4 Four-point bending test arrangement

All 45 specimens, including those in the control group, were tested destructively to failure by flexure according to ASTM C880/C880M [22]. A four-point bending test rig placed in Instron 5500R/6027 testing machine was used as shown in Fig. 4. The 4-point bending test was performed on the specimens with a span length (L) of 320mm, which is 10 times the specimen's thickness. The overall length of each specimen was limited to 400mm. A rigid steel loading frame was used to facilitate the roller support arrangement; the two point loads ($W/2$ each) were placed 80mm ($L/4$) inward from each support and 160mm ($L/2$) apart from each other. All the specimens were tested with the polished face down, at a monotonic loading rate of 0.05 mm/min consistent with ASTM recommendation of 4.14MPa/min. The maximum applied load was measured from the load cell data, while the length, orientation and the average thickness at the failure plane were measured and recorded at the completion of each test.

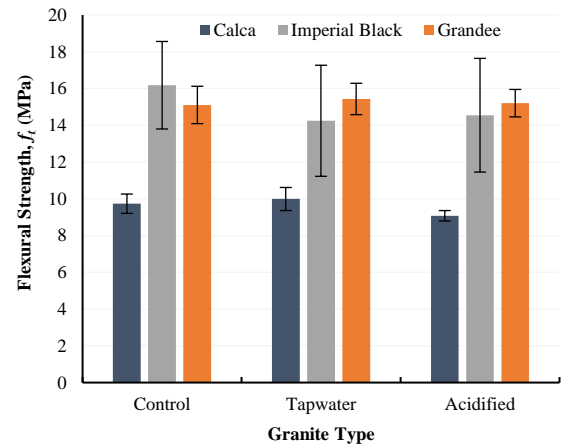
Fig. 5 Flexural strength of granite specimens

Figs. 5 shows the average flexural strength, f_t of the unweathered and weathered granite specimens obtained from the four-point bending tests. The results demonstrate that f_t of the Imperial Black, Calca and Grandee control specimens was 16.18 MPa, 9.73 MPa and 15.11 MPa, respectively. For the weathered tap water group specimens, f_t was 14.25 MPa, 9.99 MPa and 15.43 MPa; while for the acidified group f_t was 14.55 MPa, 9.08 MPa and 15.2 MPa, respectively. No simple trend could be established to account for the effect of WDC by tapwater and acidified solution within each granite group. Based on the results shown in Fig. 5, it can be inferred that Imperial Black was the only granite type affected by the WDC. The Imperial Black tapwater group experienced the highest loss in flexural strength of 11.96%. There was a slight loss in flexural strength of Calca acidified group of 6.7%; although the tapwater group shows 2.6% increase in f_t . Flexural strength of the weathered tapwater and acidified groups of Grandee increased by 2.2% and 0.6%, respectively. Factors such as the highly polished surface, grain distribution and porosity of the stones and the accumulation of salts [17, 25] may have contributed towards this trend. The non-porous surface of Imperial Black and Grandee samples provided resistance against water and acids attack, whereas the semi-porous surface of Calca allowed deposition and accumulation of salts which may be present in tapwater.

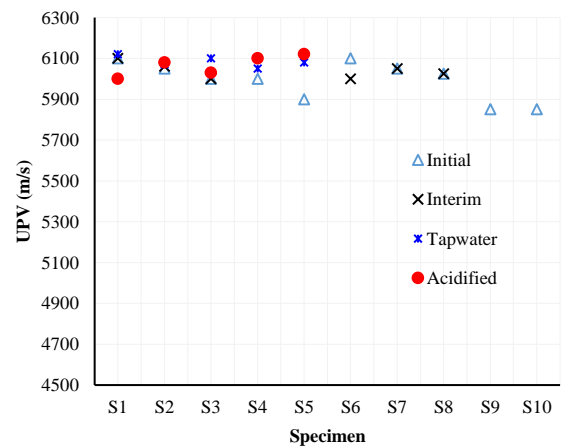
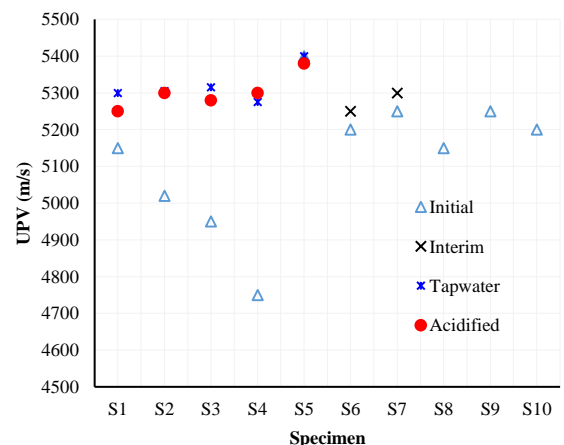
Fig. 6 UPV of Imperial Black specimens measured along (a) Width; (b) Thickness

Figs. 6 (a) and (b) show the UPV values for all the Imperial Black specimens measured along the width and the thickness, respectively. UPV is measured at the unweathered state labelled as initial in Fig. 6, and weathered specimens after stage – I and stage – II WDC labelled as interim and tapwater/acidified, respectively. The average UPV of unweathered Imperial Black specimens measured along the width were 5992 ± 94.32 m/s which is consistent with the findings of [5]. It was noticed that the UPV measurements along the width of the specimen was higher than that along the thickness direction. UPV measured across the width of the Imperial Black specimens at the following stages; initial, interim, tapwater and acidified were 16.8%, 14.5%, 14.3% and 14.4% higher than that of the respective measurements taken across the thickness of the specimen. Variation in UPV due to WDC was insignificant, interestingly some of the weathered specimens showed slightly higher UPV value over their unweathered counterpart.

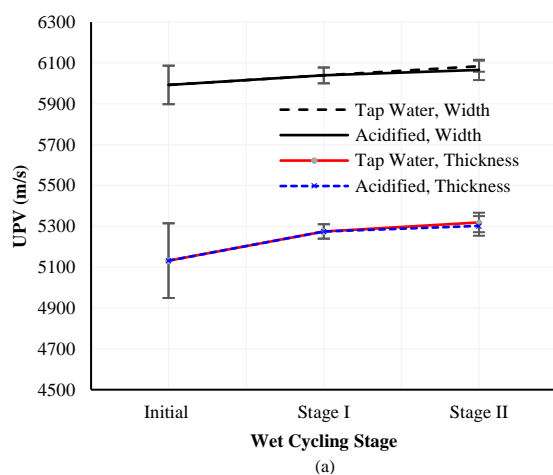
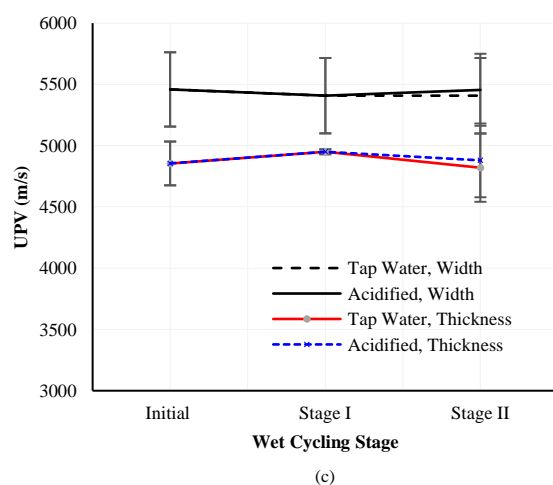
**Fig. 7** Average UPV of unweathered and weathered specimens (a) Imperial Black; (b) Calca; (c) Grandee

Fig. 7a-c show the average UPV values of the Imperial Black, Calca and Grandee specimens at different stages of weathering. The average UPV values measured along the width and thickness of the specimens are shown in Table 2. Larger standard deviation is observed among the UPV measurements across the thickness of the specimen, than that of the width. The UPV readings were the most consistent within Imperial Black specimens, while readings taken on Grandee specimens showed the highest variation. No difference was expected between the average UPV values of tapwater and acidified groups of each granite type in the initial and interim stages, as they were subjected to identical conditions. However, following Stage – II WDC, differences in UPV values emerged. The average UPV of the acidified group of Calca and Grandee specimens were 0.49% and 0.89% higher than that of the tapwater group, while it was 0.3% lower for the Imperial Black specimens.

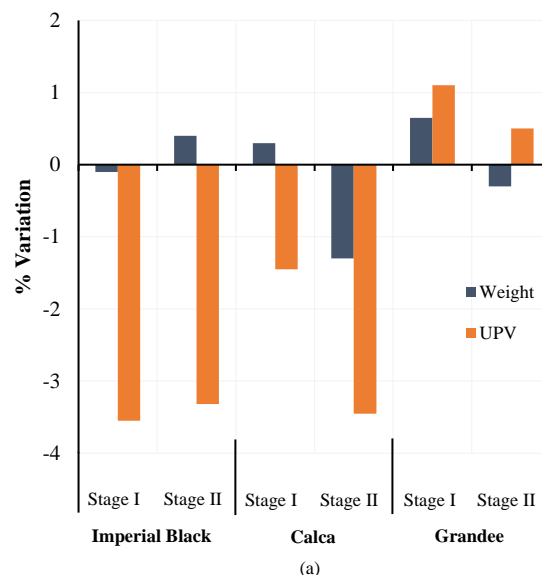
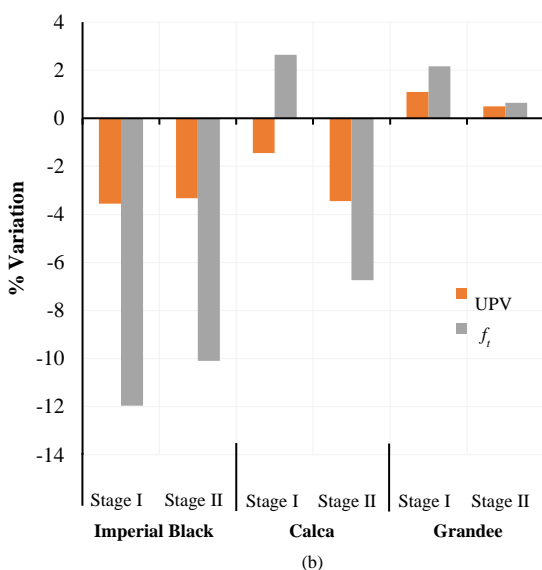
**Fig. 8** Percentage loss (a) Weight and UPV; (b) Flexural Strength and UPV

Fig. 8 (a) shows the variation in weight and UPV experienced by the granite specimens at different stages of the WDC, where the positive and negative variation represent the gain and loss in the parameters, respectively. Samples were weighed before the WDC and after the 50th and 100th cycle. The weight losses of the granite specimens were small. Only the Calca acidified group specimens experienced an average weight loss of 1.34% (equivalent to 47g of material). No definitive weight loss pattern could be established. It was also found that several specimens from all granite types experienced slight gain in weight (0.3 – 0.65%) which is consistent with those reported in [17, 26]. Many sources such as incomplete desiccation of samples, change in chemistry of the constituent minerals, accumulation of salt introduced from the immersion liquids during the wetting cycles could contribute to the increase in the weight of the granite specimens.

Loss in the UPV value in response to the WDC was more prominent than the loss in weight of the specimen. Although no consistent relation could be established between the losses in weight and the losses in UPV. The maximum loss in UPV was recorded for the Imperial Black specimens of 3.55%, after the stage – I weathering, while the acidified group of Calca specimens endured an average UPV loss of 3.45% after the WDC. On the contrary, the tapwater and acidified group Grandee specimens experienced an average UPV gain of 1.1% and 0.5%, respectively.

Fig. 8(b) shows losses in UPV and f_i experienced by the granite specimens at different stages of WDC. The loss in f_i under WDC is higher compared to the loss in UPV. The Imperial Black specimens after the stage – I weathering showed an average 11.96% loss in f_i . A similar trend between UPV and f_i is

observed for Imperial Black and the Grandee specimens unlike that for the Calca specimens. The tapwater group Calca and Grandee specimens experienced an average gain in f_t of 2.64% and 2.16%, respectively. According to Fig. 8(b) the Grandee specimens were the least affected by the WDC.

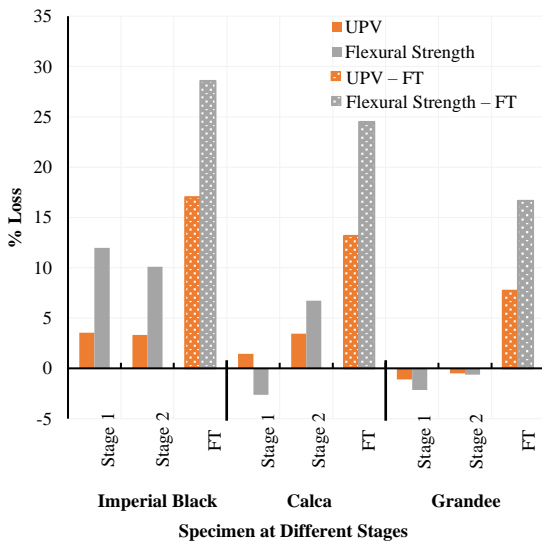
Fig. 9 Percentage loss due to WDC and FTC

Fig. 9 shows the variation in f_t and UPV of the granite specimens following stage – I and – II WDC, and the same following FTC weathering reported in [5]. The Fig. shows that losses in f_t and UPV of the granite specimens was more pronounced under FTC than under WDC. The Imperial Black specimens experienced an average loss in f_t of 28.56% due to FTC, which is 2.39 times higher than the losses due to WDC.

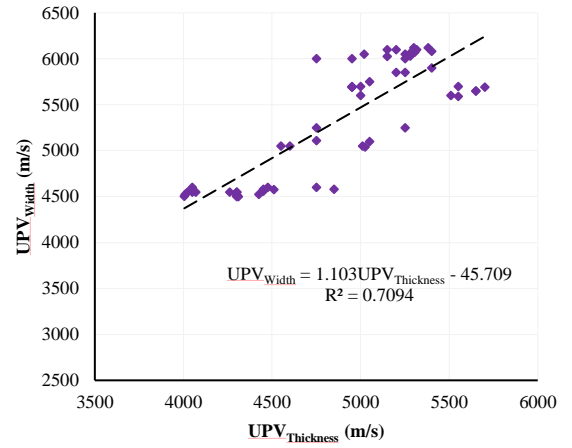
Fig. 10 Correlation between UPV along width and thickness of specimen

Linear correlation between UPV values measured along the width and the thickness direction of the granite specimens is shown in Fig. 10 and given by eq 2 with $R^2 = 0.709$. The developed relation in eq 2 can be used to predict the UPV value of granite panels along the width when measurement is only possible in the thickness direction.

$$UPV_{Width} = 1.103UPV_{Thickness} - 45.709 \quad (2)$$

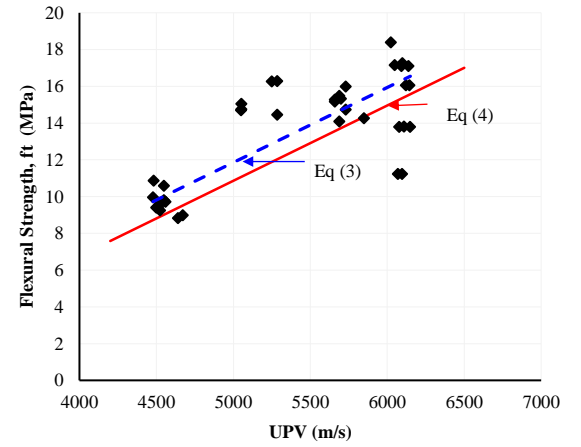
Fig. 11 Correlation between UPV and flexural strength

Fig. 11 shows the relation between $f_{t,WDC}$ obtained from destructive test and measured UPV along the width of all 45 unweathered and weathered (i.e., tapwater and acidified groups) granite specimens from the WDC testing. Based on the obtained results, a linear correlation is established as shown in Fig. 11 and eq 3 with $R^2 = 0.57$ that can be used to predict the on-site $f_{t,WDC}$ of the granite cladding panels by means of the measured pulse velocity.

$$f_{t,WDC} = 0.0041UPV_{mean} - 8.55 \quad (3)$$

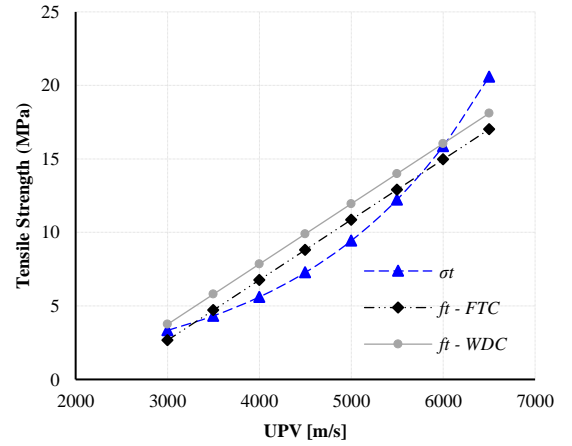
Fig. 12 Predicted direct and flexural tensile strength using UPV

Performance of the proposed eq 3 for the flexural tensile strength $f_{t,WDC}$ is compared against eq 4 and those proposed by other researchers [8] for the direct tensile strength σ_t (eq 5). A range of UPV between 3000 m/s to 6500 m/s was selected for the comparison.

Fig. 12 shows the predicted tensile strength ($f_{t,WDC}$, $f_{t,FTC}$ and σ_t) using Eqs (3), (4) and (5) against the corresponding UPV values, and the results seems reasonable.
